# DeLorean Owners Association Regional Chapter 41

August 4, 1996

### **Happenings**

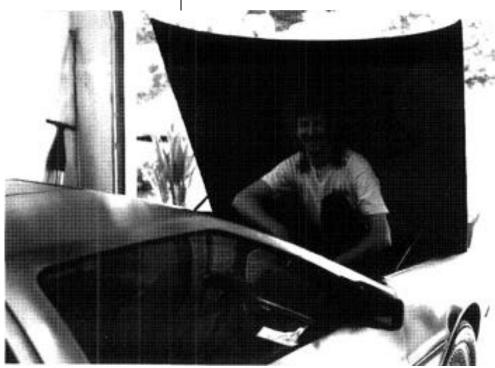
Yours truly conducting preventive maintenance on the DeLorean fuel system.

As promised in the last issue, I replaced the fuel pump boot and cover seals. These are the culprits in fuel system contamination usually associated with improper storage. On my car, the fuel pump boot was clearly starting to deteriorate and the cover seal was as hard as a rock and had to be cut off the top of the pump. My pump was also showing signs of damage due to the poor seal the boot and cover seal made and was markedly pitted by corrosion. Fortunately, Chris happened to bring a spare, so I replaced it as well.

recommend that you examine your fuel pump boot and associated seals after your car has been stored.

After having gone through the exercise myself and seeing the deterioration firsthand, I would
